# Corrosive properties of different surfaces to understand the degradation mechanism of paint film

Inadequate surface preparation of mild steel panels prior to painting could be the leading cause of the paint film failure. This work evaluated the surface preparation treatments in order to improve the paint integrity and thereby increasing the corrosion resistance of the steel panel in artificial sea water. The AISI 1020 steel ground and grit blasted samples were prepared followed by applying zinc based epoxy primer and top coat. The degradation mechanism was devised by immersing the samples in 3.5% NaCl solution. The degradation due to blistering within the paint was analyzed by following ASTM D-610 and ASTM D-714. Energy Dispersive Spectroscopy of corrosion product revealed a correlation with the degradation mode of painted sample. It was deduced that degradation of paint depends on surface morphology of substrate.

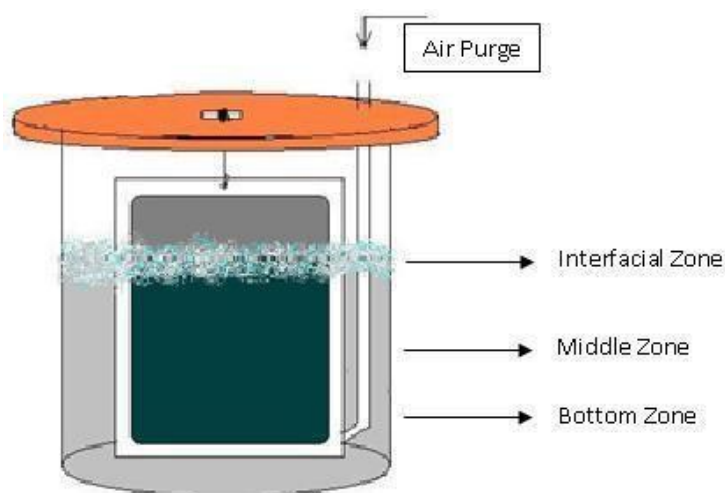
Figure 1. Panel immersed in aerated 3.5% NaCl.

The cured painted panels were then immersed in artificial aerated sea water (3.5% NaCl solution prepared in de-mineralized water) to analyze the painted surfaces performance under accelerated conditions. The 2/3 portion was immersed in solution while 1/3 portion was out of solution in order to simulate the paint film behavior in the bottom, middle and interfacial. The severity of electrolyte towards paint deterioration was measured in all these zones by visual and microscopic examination. The experimental cell is shown in Figure 1.

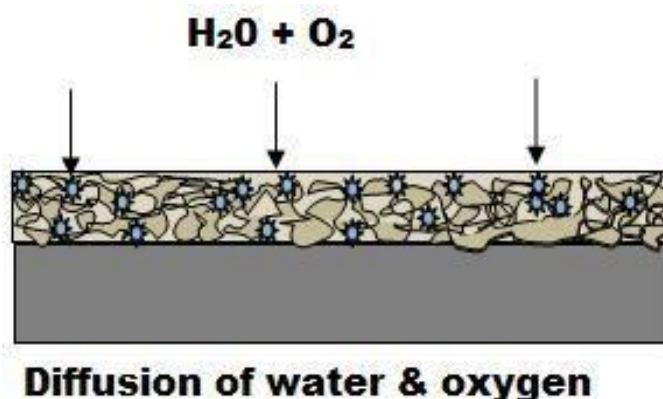
Figure 2. Take up of aerated water by the paint film within incubation period.

The incubation period is always required for the initiation of a blister on polymer-coated steel panels. For panels containing no apparent defects or small pores, the time taken by the blisters to nucleate is much longer than for panels containing defects [Robert et al., 1997; Chuang et al., 1999]. The water uptake by the polymer film is a function of degree of crosslinking and film thickness. In saline solutions the diffusion of ionic species through the film also depend on chain structure and length of diffusion path. High degree of crosslinking limit the approach of water and ions to the steel surface due to tortuous path

within the polymer film as depicted in Figure 2. The paint condition before immersion was as presented in Figure 3a. The absorption of water within the intrinsically defective paint film chain structure will cause a concentration gradient in the film for more water take up hence causing swelling as shown in Figure 3b. The initial 72 h delay in blister formation, when G02 painted surface was immersed in a water solution containing salt, the diffusion was gradual leading to film swelling with a volume expansion. The corrosion spots were appeared at surface of paint film which estimated according to ASTM D610 were close to rust grade 8-S (0.1% Rusted).

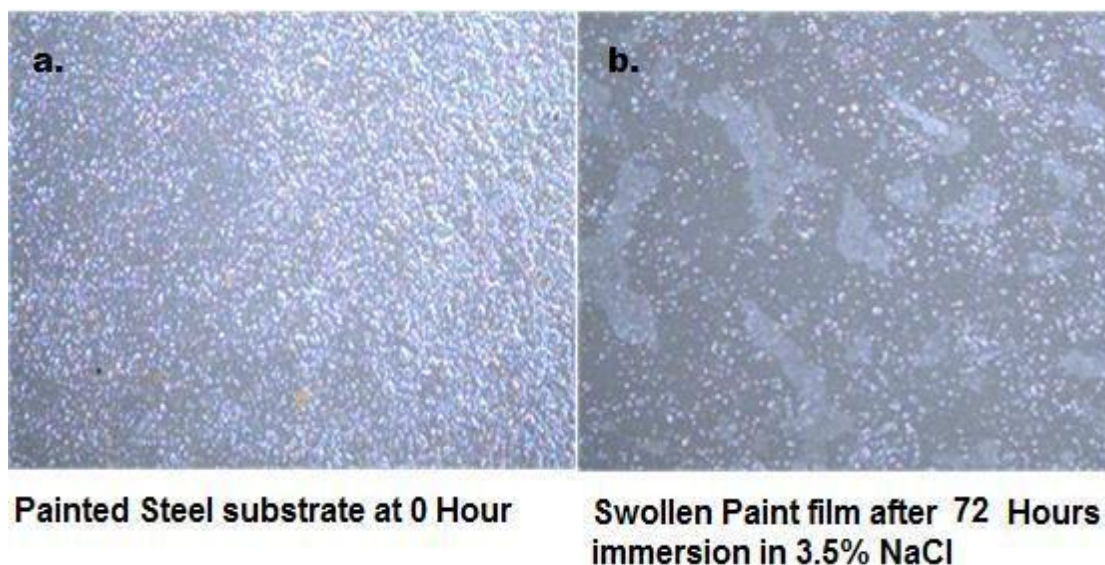
**Figure 3.** G02 paint film surface condition at (a) 0 hour (b) 72 h.

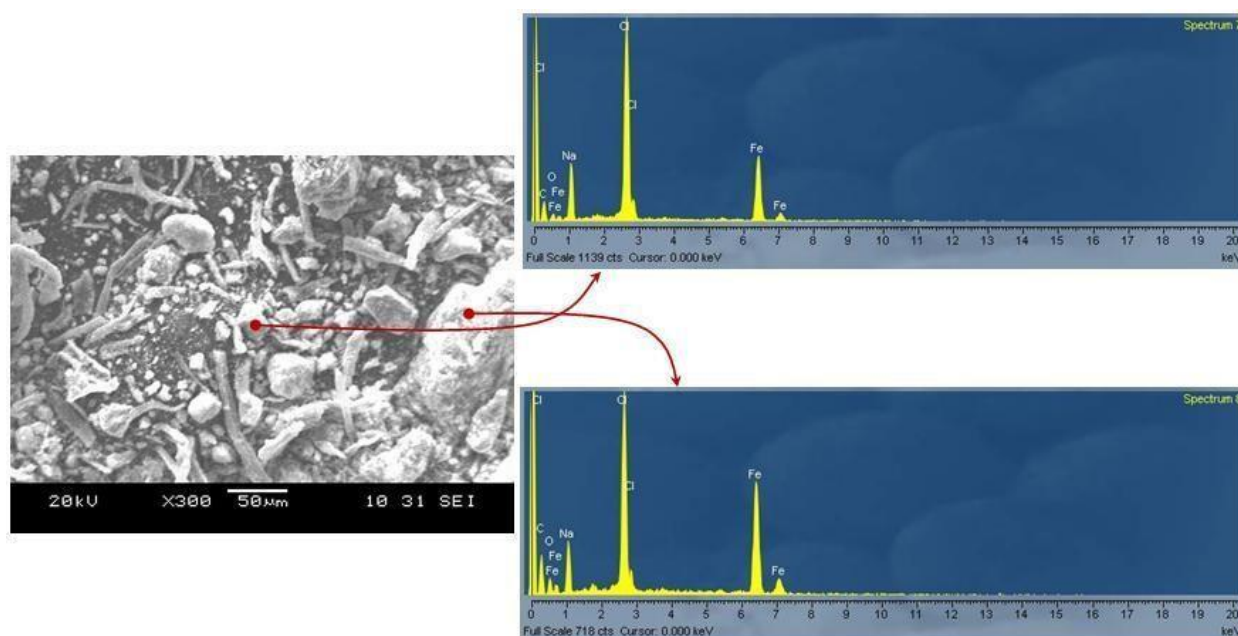
Figure 4. SEM, Energy dispersive spectroscopy elemental analysis.

The formation of NaOH locally at the Blister initiation site increased the pH blister solution to 8. The Energy Despersive Spectroscopy (EDS) elemental analysis at the rust spot qualitatively validated the presence of  $Na^+$  and  $Cl^-$  ions in the spectrum as shown in Figure 4. The high intensity peaks of  $Cl^-$  in EDS spectrum represented the domination of  $Cl^-$  ions ingress at the paint/metal

interface than  $\text{Na}^+$  ions.

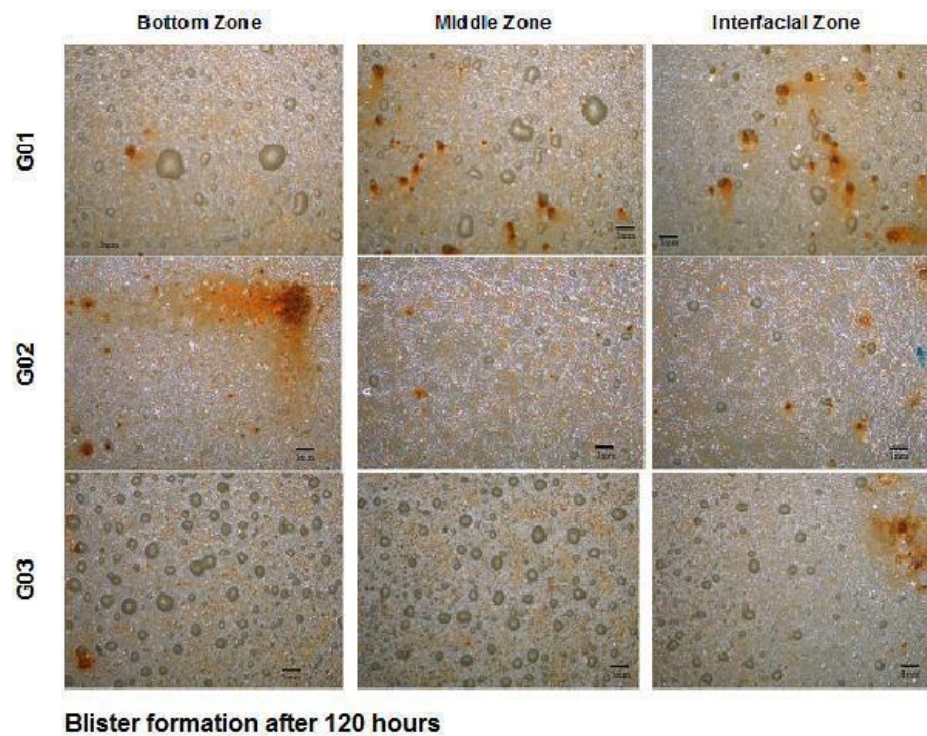
Figure 5. Stereo-micrographs of blister formation after 120 h immersion.

The pictorial view of blister growth when painted steel panels were exposed to artificial sea water is shown in Figure 5 to 7 for 120, 240 and 480 h respectively.

The pictorial data of samples G01, G02 and G03 is provided in Tables 3 to 5 respectively for the evaluation of blister size, frequency and rust grades by following ASTM D-714 and ASTM D-610 respectively. It was evaluated from data that the blister growth rate was higher for G01 and G03 due to comparatively least surface area available for uniform adhesion to the steel surface than the rougher surface of G02. It was therefore very few blister having size 10 and rust grade 6 even after 120 h at the bottom zone of panel. The detail of paint surface blister and rusting grades at the bottom, middle and interfacial zones of panel may be predicted from these tables.

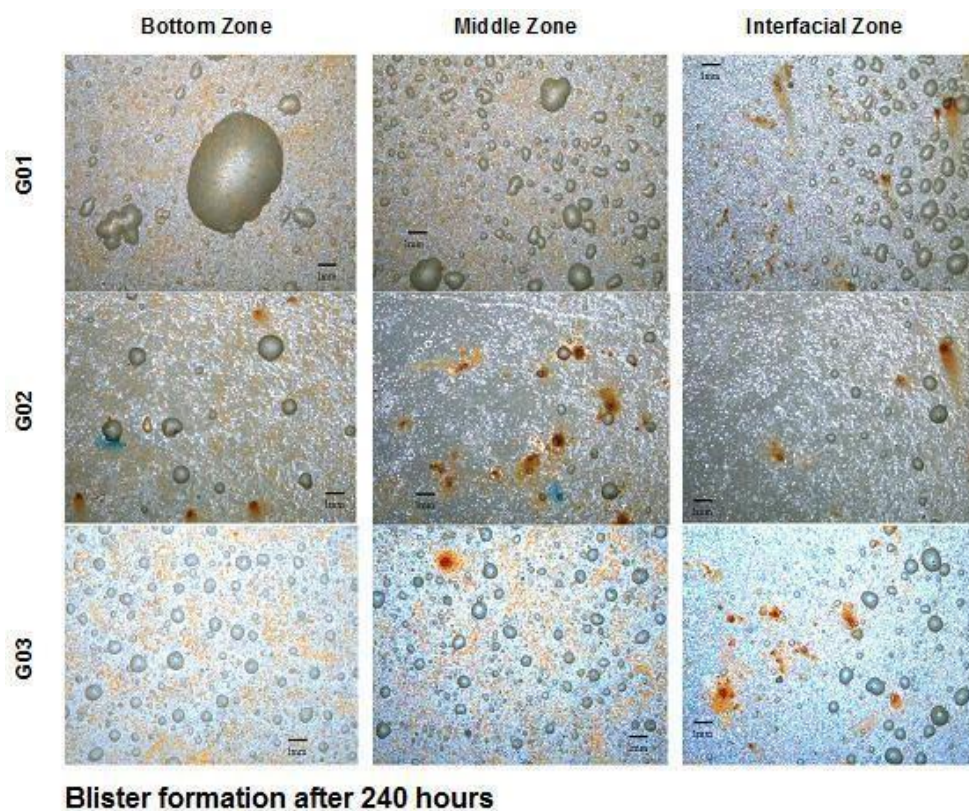
Figure 6. Stereo-Micrographs of painted surfaces after 240 h.

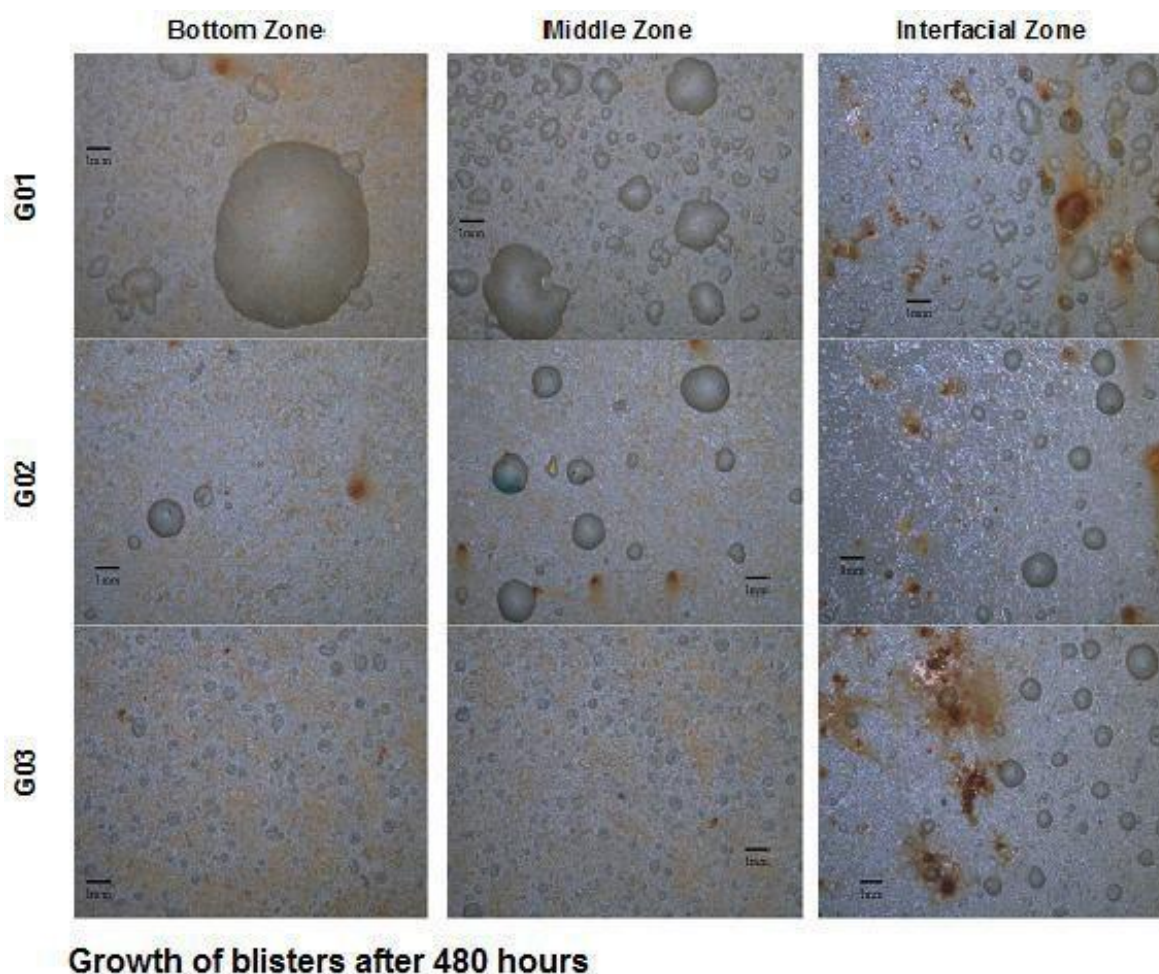
Figure 7. Stereo-micrographs of painted samples after 480 h.
